The Office of the Auditor General's
investigation of the PSA's follow-up
of health, safety and environment in
the petroleum industry

Document 3:6 (2018–2019)

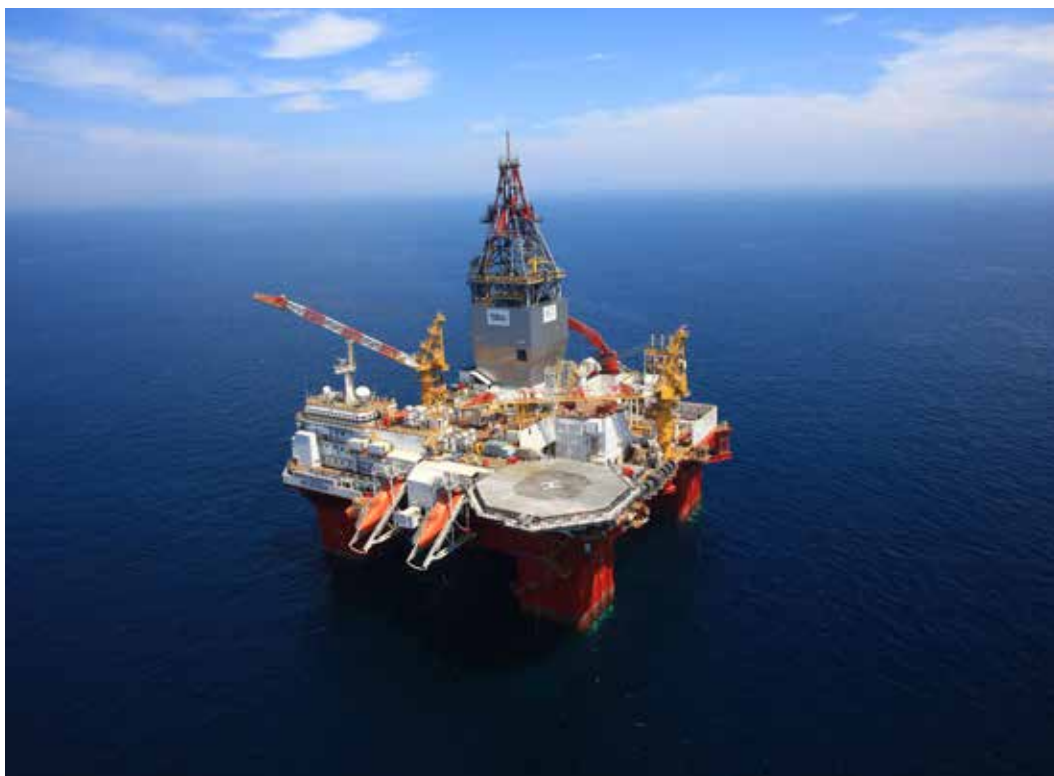
The well control incident on the Songa Endurance drilling rig is one of the most serious to have ever occurred on the Norwegian continental shelf. Source: Transocean.

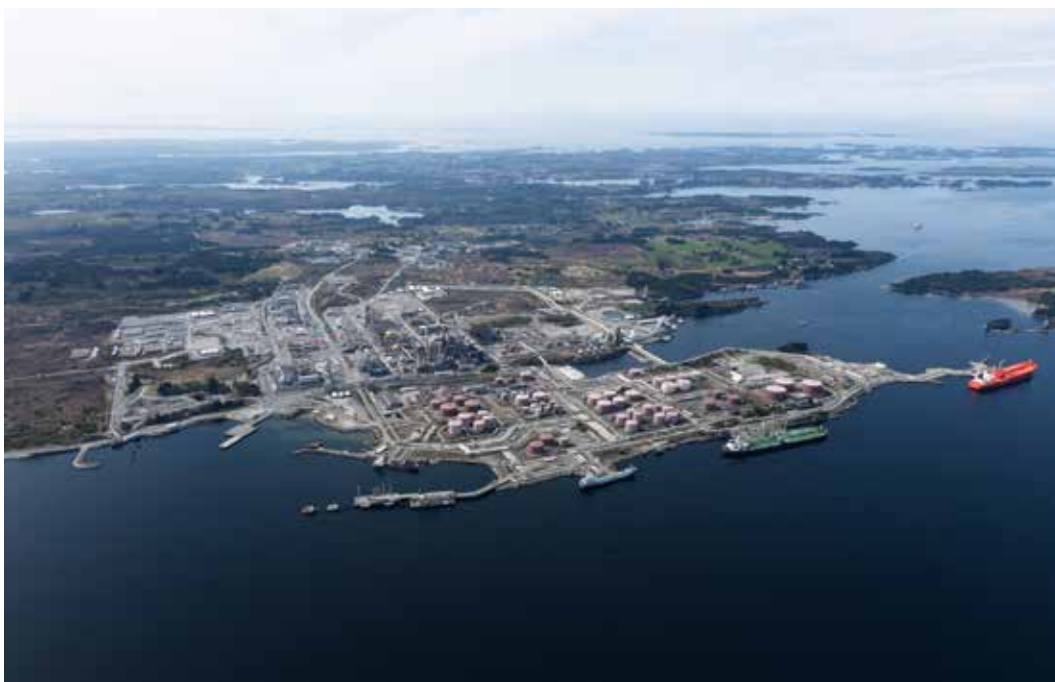
Cuts to appropriations for maintenance work, in combination with the failure to follow up on regulatory nonconformities, contributed to the serious incident at the Mongstad onshore production facility in 2016. Source: Helge Hansen, Equinor
